2024 Checklist for P.E. Annual Inspection for CCR Surface Impoundments, § 257.83(b)

Sikeston BMU Sikeston Power Station Fly Ash Surface Impoundment Annual Inspection

**SIKESTON POWER STATION – FLY ASH POND
2024 ANNUAL INSPECTION CHECK SHEET**

**FIGURE 1
FLY ASH POND
2024 ANNUAL INSPECTION**

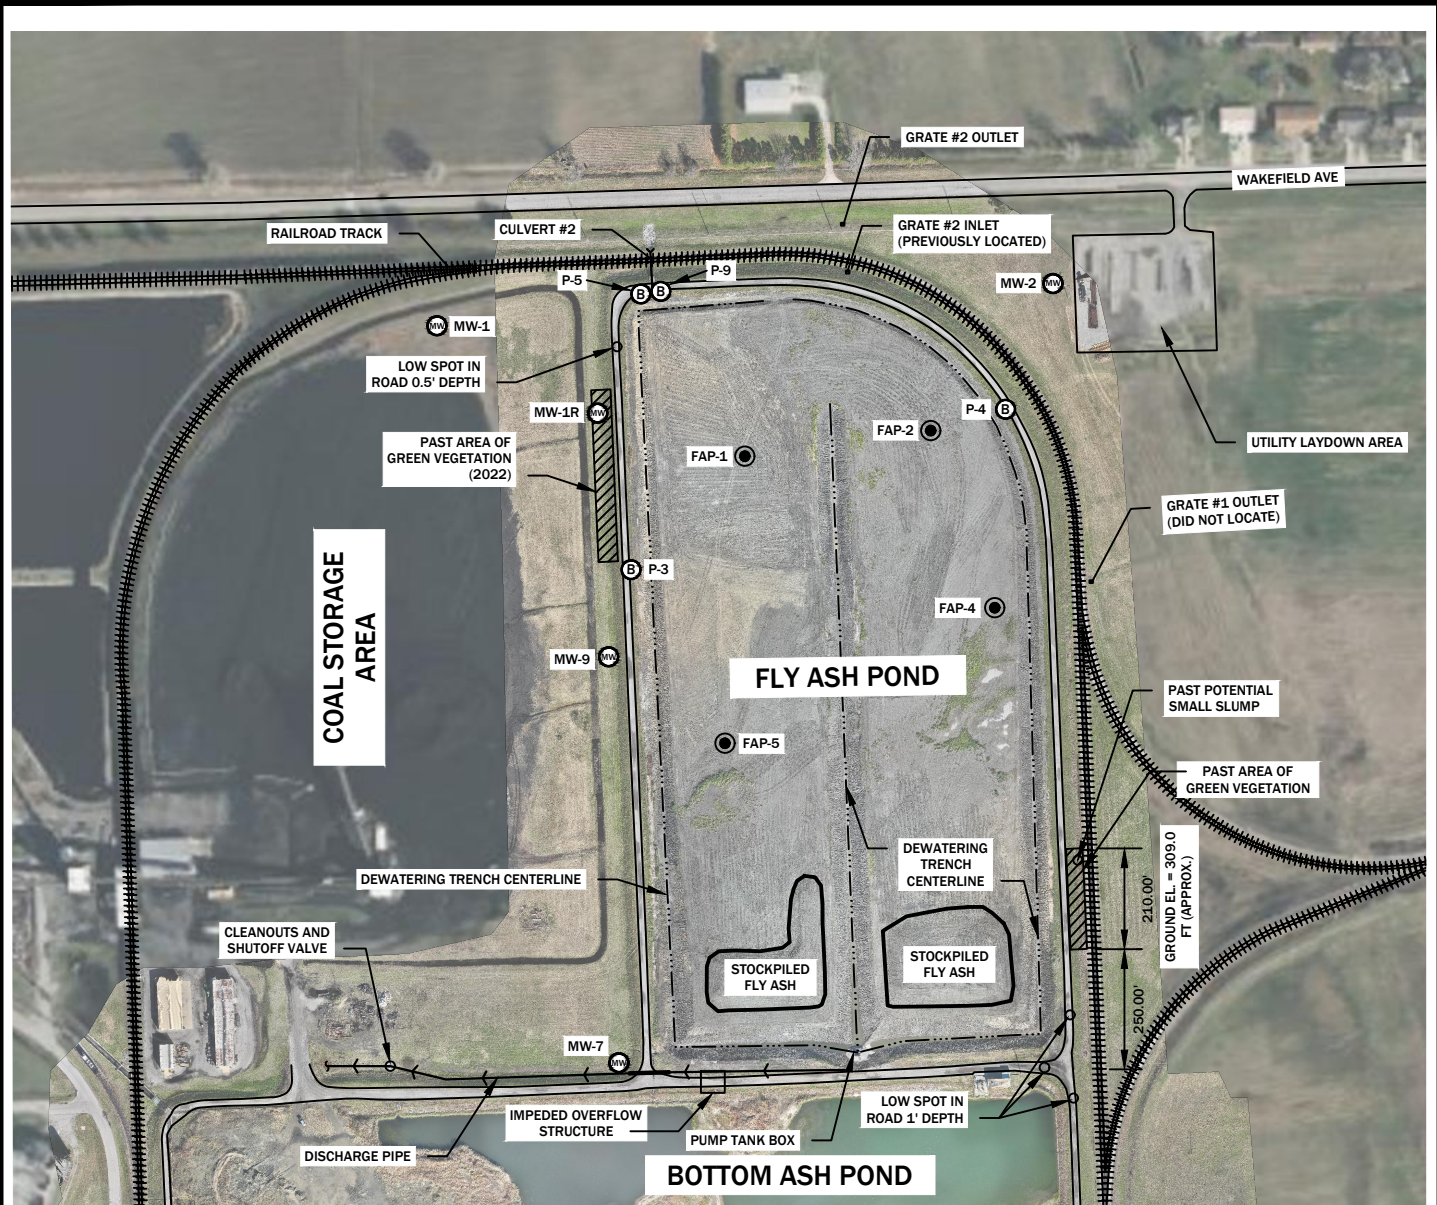
1. The location of observations on attached plan sheet (Figure 1).

1. MINOR MAINTENANCE ITEMS INCLUDE:
 - a. TWO LOW SPOTS IN THE BERM ROAD: ONE NEAR SOUTHEAST CORNER; AND ONE NEAR NORTHWEST CORNER.
2. ITEMS RECOMMENDED FOR CONTINUED OBSERVATION INCLUDE:
 - a. GREEN VEGETATION IN THE AREAS ALONG THE SOUTHEAST BERM AND NORTHWEST BERM INDICATES POSSIBLE SEEPAGE. CONTINUED OBSERVATION RECOMMENDED.
 - b. PERIODIC WATER LEVEL READINGS IN THE FOUR (4) PIEZOMETERS INSTALLED WITHIN THE POND IN CCR MATERIALS.
3. ITEMS IDENTIFIED DURING THE ANNUAL INSPECTION WHICH DO NOT REQUIRE MAINTENANCE:
 - a. THE IMPEDED OVERFLOW STRUCTURE BETWEEN THE BOTTOM ASH POND AND THE FLY ASH POND.
 - b. PERMANENTLY CLOSED DISCHARGE STRUCTURE.
4. PIEZOMETER LOCATIONS APPROXIMATED WITH HANDHELD GPS.
5. GRATE #1 INLET NOT IDENTIFIED.
6. IN 2024, THE PONDED CCR WAS GRADED TO PROMOTE CCR DEWATERING AND IMPROVE STORMWATER COLLECTION AND REMOVAL IN PREPARATION FOR CLOSURE.
